MAGNETIC PARTICLE INSPECTION REPORT

Company Name and Address TRUCK OMAN NORTH LLC		Inspection Location: FAHUD RM
Certificate Number: MM.3296.02.26.26.01		Job No: 03296
Date of Thorough Examination: 26-02-2026	Time of Inspection: 07:00	Issue Date: 10-03-2026
Date of Previous MPI/ cert no: N/A		Date of Next Examination: 25.08.2026
Description : 3.5" FIFTH WHEEL MPI		
Description and identification of the equipment: REG NO: 8523 BA(TO 2142)

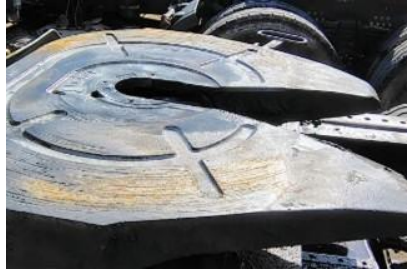
Area Inspected (tick the appropriate box): <input type="checkbox"/> Weldment areas <input type="checkbox"/> Stress Areas <input type="checkbox"/> Full Body <input checked="" type="checkbox"/> Others (top surface)		
WHITE CONTRAST PAINT: ZCHEK WP		MAGNETISING METHOD: WET SUSPENSION BLACK INK
BLACK MAGNETIC INK: ZCHEK 9E Black		ACCEPTANCE CODE: ASME V ARTICLE 7 , ASTM E709 ,AWS D1.1
TEST METHOD: WET		MATERIAL: CARBON STEEL
TEST TEMPERATURE: AMBIENT		SURFACE CONDITION: ACCEPTABLE
TEST EQUIPMENT: PERMANENT MAGNET YOKE

Result of the above test: MPI TEST CARRIED OUT SATISFACTORILY, FOUND NO RELEVANT INDICATIONS AT THE TIME OF INSPECTION
