MAGNETIC PARTICLE INSPECTION REPORT

Company Name and Address TRUCK OMAN EQUIPMENT RENTAL LLC	Inspection Location GHALA		
Certificate Number: MM.0268.11.23.16.03	Job No: 0268		
Date of Thorough Examination: 16.11.2023	Issue Date: 16.11.2023		
Date of Previous MPI/ cert no: NEW	Date of Next Examination: After One Year As Per Clients Requirements Or At The Discretion Of Inspector		
Description and identification of the equipment: FORK MPI			
Make: LIUGONG / 2024 Reg No: 8372 AK Fork Serial No: 20230907001

Company Name and Address TRUCK OMAN EQUIPMENT RENTAL LLC	Inspection Location GHALA
Certificate Number: MM.0268.11.23.16.02	Job No: 0268
Date of Thorough Examination: 16.11.2023	Issue Date: 16.11.2023
Date of Previous Examination/ Cert No: NEW	Date of Next Examination: After One Year As Per Clients Requirements Or At The Discretion Of Inspector
Description and identification of the equipment: BUCKET MPI	
Make: LIUGONG / 2024 Reg No: 8372 AK Bucket Serial No: GD2307085

Company Name and Address TRUCK OMAN EQUIPMENT RENTAL LLC		Inspection Location GHALA	
Certificate Number: MM.0268.11.23.16.04		Job No: 0268	
Date of Thorough Examination: 16.11.2023		Issue Date: 16.11.2023	
Date of Pre

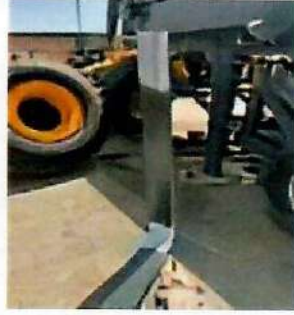
Area Inspected (tick the appropriate box):			
<input type="checkbox"/> Weldment areas	<input checked="" type="checkbox"/> Stress Areas	<input type="checkbox"/> Full Body	<input type="checkbox"/> Others (top surface)
WHITE CONTRAST PAINT: MAGNAVIS WCP		MAGNETISING METHOD: WET SUSPENSION BLACK INK	
BLACK MAGNETIC INK: MAGNAFLUX 7HF		ACCEPTANCE CODE: ASME V ARTICLE 7 , ASTM E709 ,AWS D1.1	
TEST METHOD: WET		MATERIAL: CARBON STEEL	
TEST TEMPERATURE: AMBIENT		SURFACE CONDITION: ACCEPTABLE

TEST EQUIPMENT: PERMANENT MAGNET YOKE			
Result of the above test: MPI TEST CARRIED OUT SATISFACTORILY, FOUND NO RELEVANT INDICATIONS AT THE TIME OF INSPECTION
