**TA'AZEEZ ENTERPRISES LLC**

### MAGNETIC PARTICLE INSPECTION REPORT

<b>Company Name and Address</b> TRUCK OMAN NORTH LLC		<b>Inspection Location:</b> FAHUD RM
<b>Certificate Number:</b> MM.3296.02.26.26.15		<b>Job No:</b> 03296
<b>Date of Thorough Examination:</b> 26-02-2026	<b>Time of Inspection:</b> 09:50	<b>Issue Date:</b> 10-03-2026
<b>Date of Previous MPI/ cert no:</b> N/A		<b>Date of Next Examination:</b> 25.08.2026
<b>Description : 3.5" FIFTH WHEEL MPI</b>		
<b>Description and identification of the equipment:</b>  REG NO: 2792-HW(TO 2147)

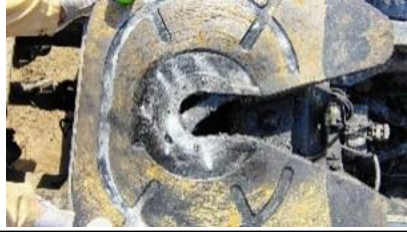
<b>Area Inspected ( tick the appropriate box):</b> <input type="checkbox"/> Weldment areas <input type="checkbox"/> Stress Areas <input type="checkbox"/> Full Body <input checked="" type="checkbox"/> Others (top surface)		
<b>WHITE CONTRAST PAINT:</b> ZCHEK WP		<b>MAGNETISING METHOD:</b> WET SUSPENSION BLACK INK
<b>BLACK MAGNETIC INK:</b> ZCHEK 9E Black		<b>ACCEPTANCE CODE:</b> ASME V ARTICLE 7 , ASTM E709 ,AWS D1.1
<b>TEST METHOD:</b> WET		<b>MATERIAL:</b> CARBON STEEL

<b>TEST TEMPERATURE:</b> AMBIENT		<b>SURFACE CONDITION:</b> ACCEPTABLE
<b>TEST EQUIPMENT:</b> PERMANENT MAGNET YOKE		
<b>Result of the above test:</b> MPI TEST CARRIED OUT SATISFACTORILY, FOUND NO RELEVANT INDICATIONS AT THE TIME OF INSPECTION
